# FEDERAL BUREAU OF INVESTIGATION

## Michigan State Police Sig Sauer M18 Evaluation

### TECHNICAL EVALUATION RESULTS

30 AUGUST 2024

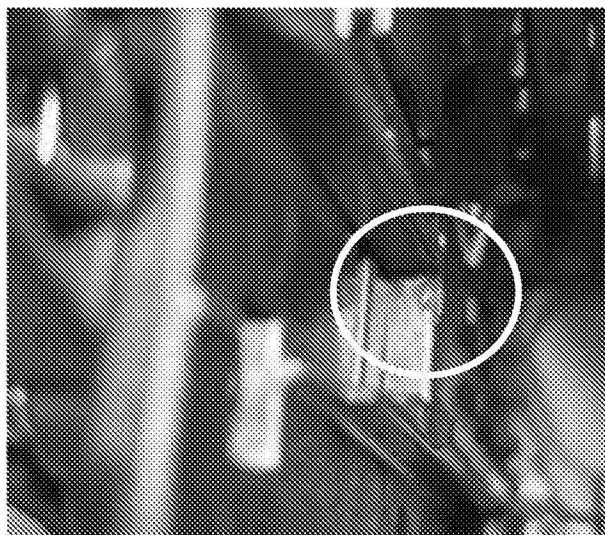
Figure 20- Holster Wear

There was no observable damage to the holster as a result of the uncommanded discharge. This is in part due to the open muzzle design of the holster which allows any debris which might fall into the holster to escape. The only observable wear was inside the holster and is a result of the takedown lever contacting a shelf inside the holster as seen below:

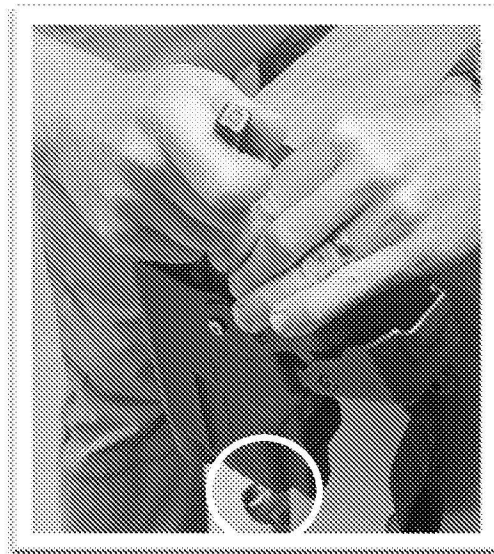
BRF staff observed the primed case fire on nine attempts with the primer indent measuring between .019"-.026" with an average of .023". While staging one attempt to allow another BRF staff member to observe the striker safety lock function as designed, the weapon was prepared and simply placed into the holster with no manipulation. A second staff member released the primary sear notch from the striker and the primed case fired indicating failure of the striker safety lock. The primer indentation measured .018"

primed case fired indicating the striker safety lock failed to stop the striker's forward movement. The primer indent measured .023".

*Figure 37 - Striker Safety Lock Primed Case Fired*
